SUBJECT: Site Inspection, Asphalt Ridge, Inc., Cameron #1 Project, S/047/036, Uintah County, Utah

Date of Inspection: August 15, 2003
Time of Inspection: about 12:45 to 1:15 p.m.
Conditions: Mostly clear, 80's
Participants: Doug Jensen and Paul Baker, DOGM

S/047/036, Cameron #1 Mine, Asphalt Ridge, Inc.

Inspection Dated: August 15, 2003; Report Dated: September 9, 2003

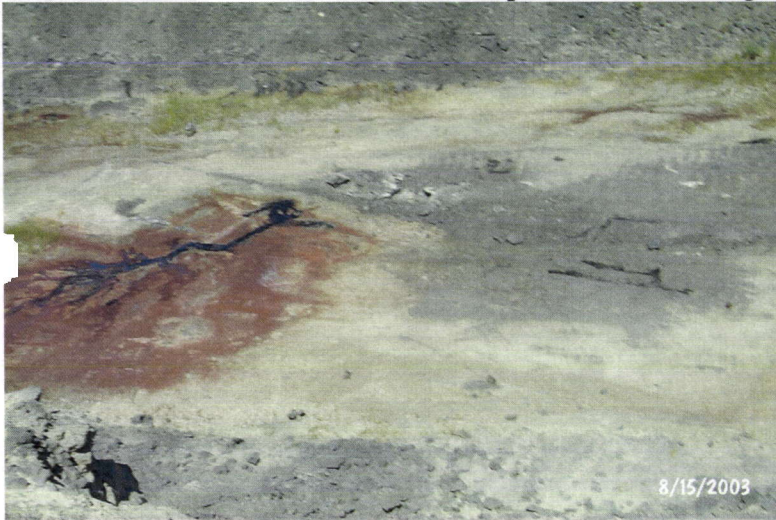
The mine area consists of a cut through something of a low ridge. There was some water seeping in to the pit area, and there was also some oil oozing from the pit walls and floor. The area of Photo 4 where the vehicle is parked appears to be a processing area.

Photo 1. Oil seeping into the bottom of the pit.

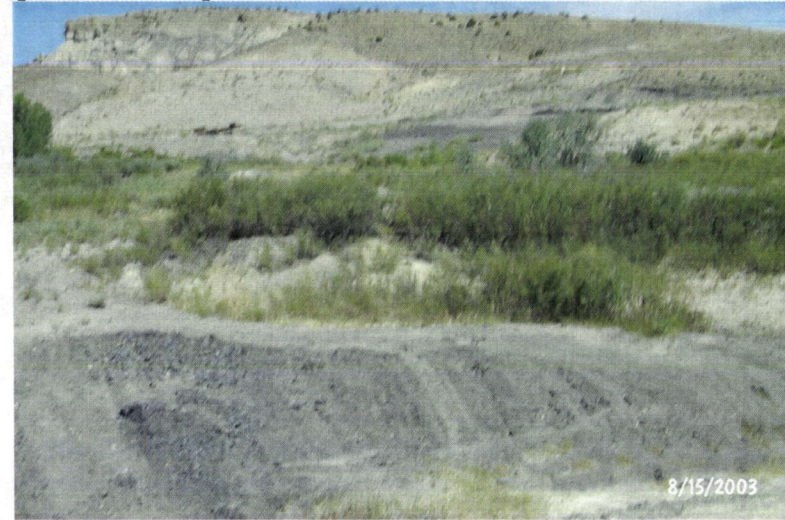
Photo 3. A portion of the mine excavation (foreground) one of the wetland areas (center), and the storage and loading area on the flat area in the distance.

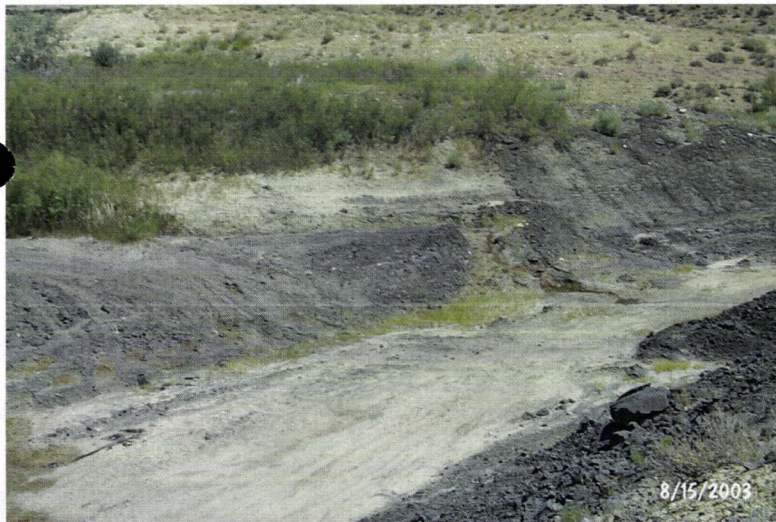
Photo 2. A portion of the mine excavation.

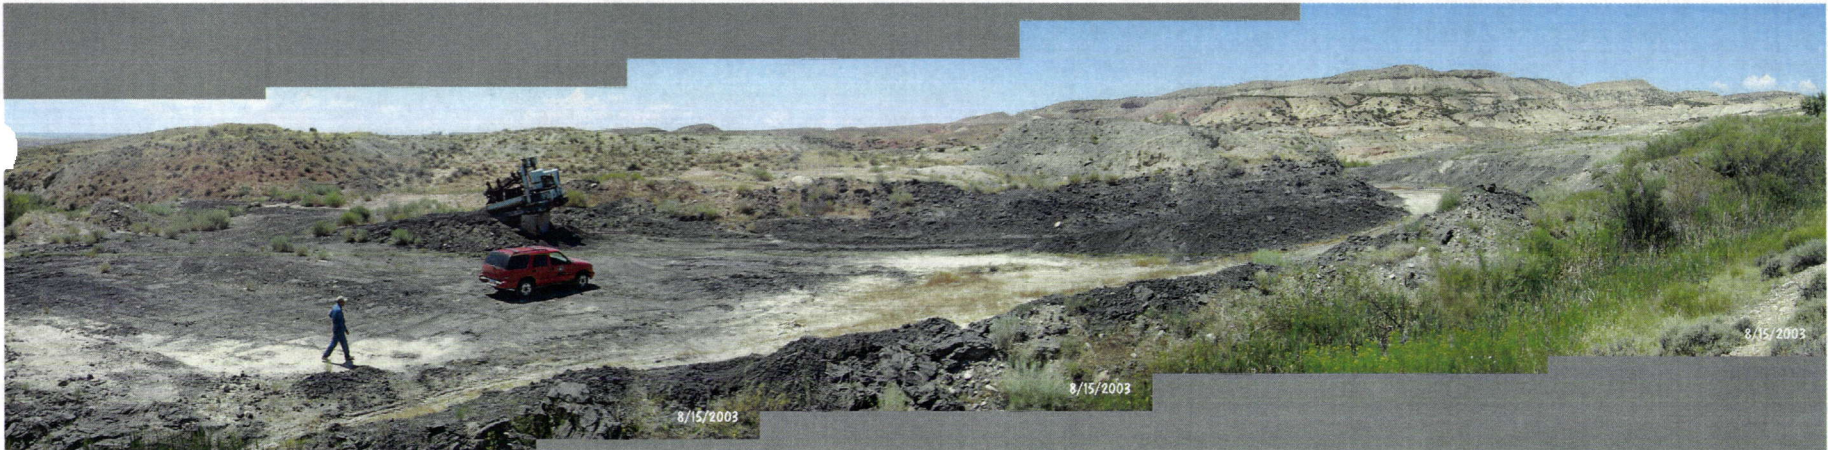
The mine is bordered on two sides by wetland areas, and part of the mine was probably within the wetland before it was disturbed. There is some running water, particularly in the green area shown on the right side of Photo 4. The water has been diverted around the mine.

Some runoff water from the pit would go directly into the small stream that bypasses the mine, and from there, I assume, into the Green River. There is no sediment control.

Photo 4. A panorama consisting of five photographs in the mine area. In the green area on the right of the picture is a small stream. The mine excavation is in the center right portion of the photo.

I suggest that a silt fence or a row of straw bales be placed to treat any potential runoff from the mine into the stream. Although I don't believe there is much risk for serious contamination of the stream, I still believe it would be best to take this step.
